Inspection Report

Minerals Regulatory Program

Mine Name: Walker Flat
Operator or Permittee Name:
Miracle Rock Mining and Research
Permittee Mailing Address:
400S. 200 E., P. O. Box 76, Emery, UT 84522

Permit number: S/015/081
Inspection Date: May 5, 2005

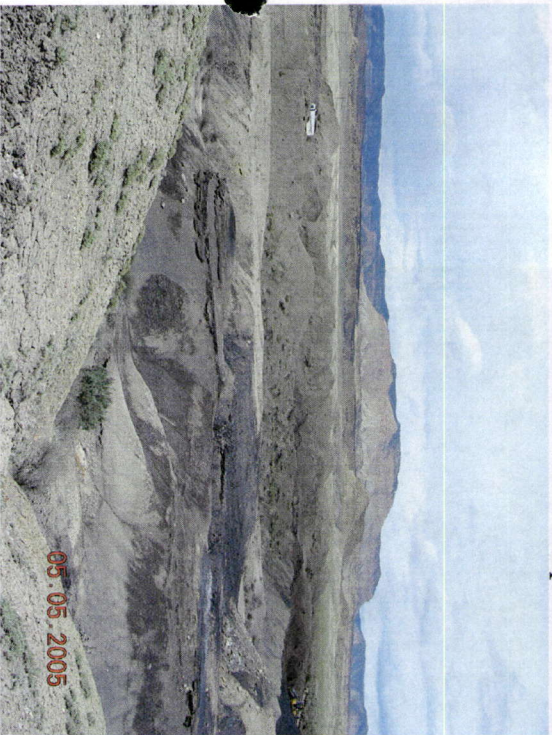
The operator is mining small plateaus right next to some small ephemeral drainages (Photo 1). While the mining is occurring, the operator builds small berms on the edge of the areas being mined. This is probably an MSHA requirement, but it also helps keep sediment out of the drainages.

Photo 1. The area near the center and to the right is being mined.

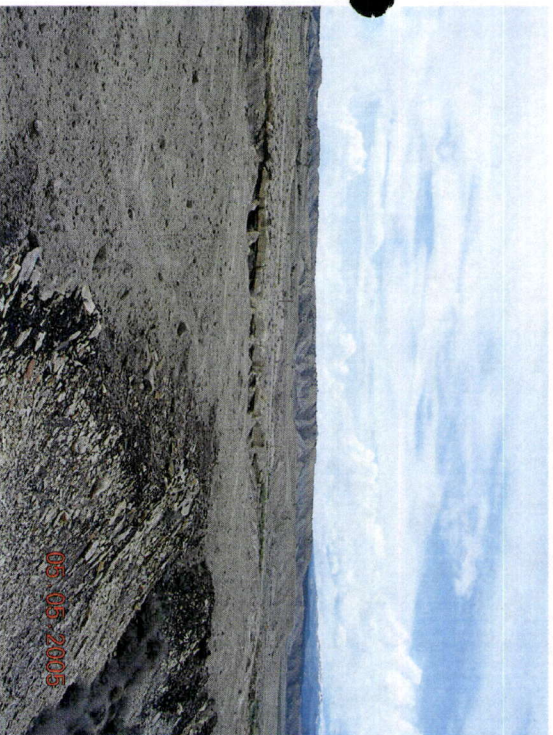
We looked at some other areas that have been reclaimed within the past one or two years. In comparison with the area reclaimed in 2002, these areas had little sandstone; most of the surface was shale-derived soil. We found just a few seeded species in these areas, but there were quite a few native annuals. It has been an unusually wet winter and first part of the spring, so I expected more plants to be growing.

Photo 2. A recently reclaimed area.

The operator should evaluate the revegetation techniques being used. If possible, some rock, particularly sandstone, should be placed on the surface. The operator should also try to make the surface rougher and should ensure that seed is applied as soon as possible after surface preparation. I do not know how the seed was handled or from where it was obtained, but care needs to be taken to store it properly and to purchase it from a reputable dealer.

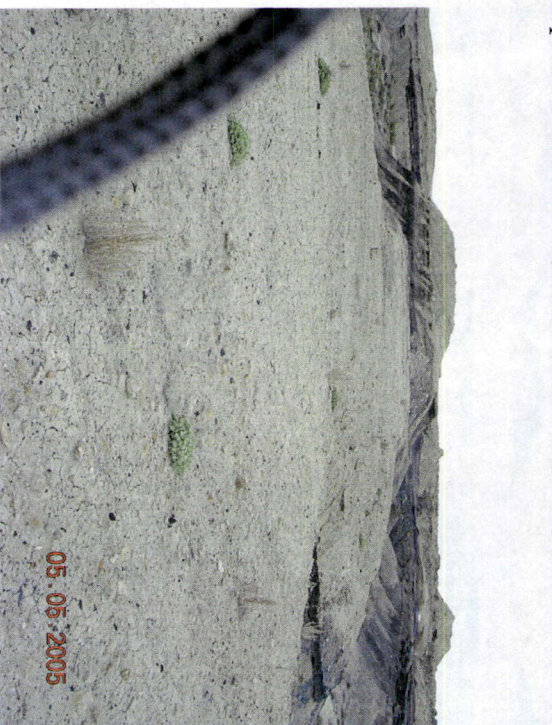
Photo 3. Another recently reclaimed area. There is not a lot of vegetation.

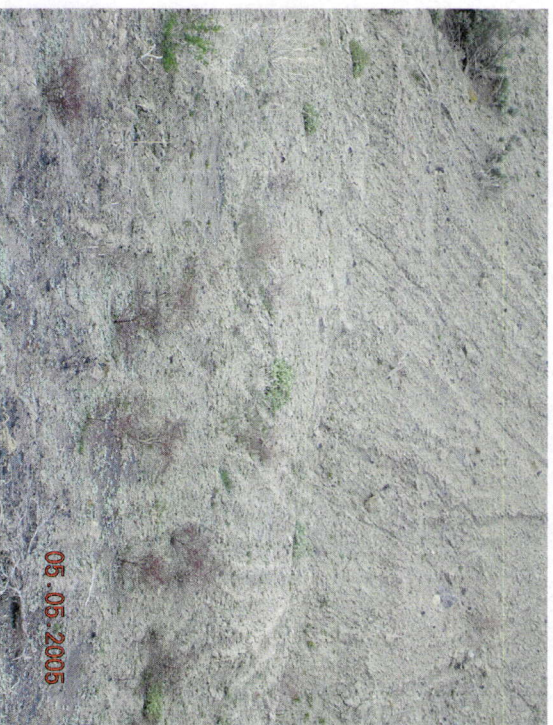
Photo 4. Still another recently reclaimed area.
